NATIONAL BUREAU OF STANDARDS REPORT

REPORT ON THE PERFORMANCE OF
ASBESTOS FIBER-BASE BUILT-UP ROOFS

7 February 1969

Thomas H. Boone and Leopold F. Skoda

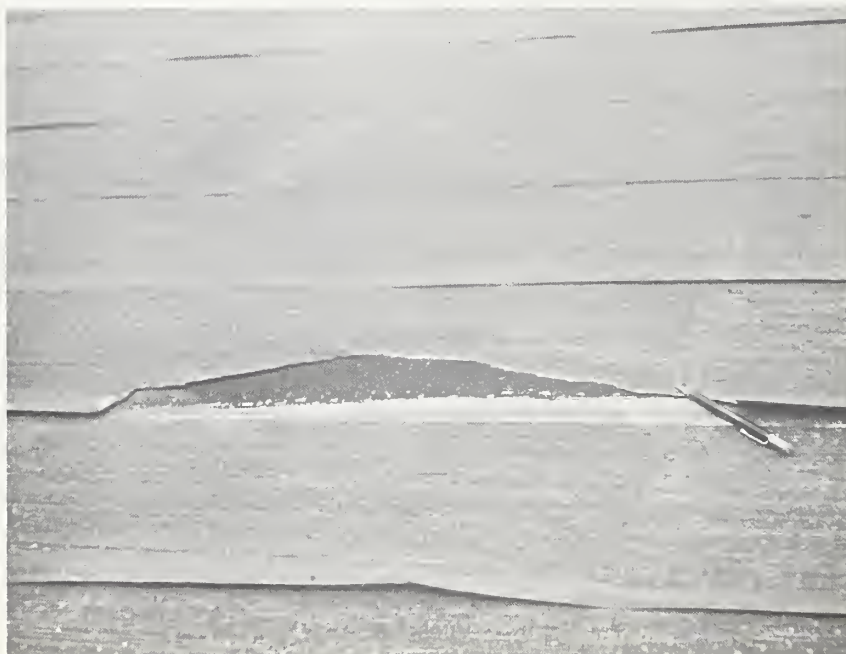
21	18	No leaks	Numerous blisters	Excellent bond between plies
22	13	No leaks	Extensive blisters	Excellent bond between plies
23	10	Subjected to several hurricanes, No leaks	Coating on south exposure worn off, Some felt torn	Excellent bond between plies
24	15	History of leaks	Roof covered with mineral cap sheet, Few large splits	Splits through complete membrane
25	15	Subjected to several hurricanes, No leaks	Coating worn off, Felts at laps delaminated & torn (see Fig. 8)	Excellent bond between plies

Figure 8. Asbestos felts delaminated and torn. This roof was subjected to several hurricanes.
